Coal Combustion Waste Impoundment

Round 5 - Dam Assessment Report

Winyah Generating Station (Site #004)

Santee Cooper

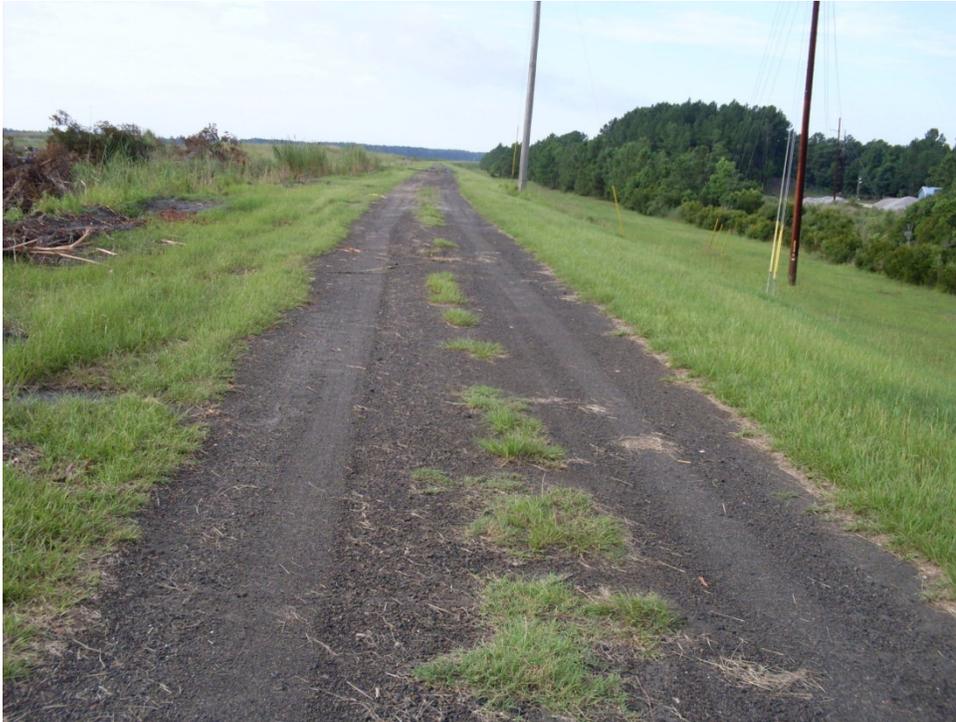
Photo BA-1: Crest of Perimeter Dike West Side of Pond A near Northwest Corner– Viewed South.

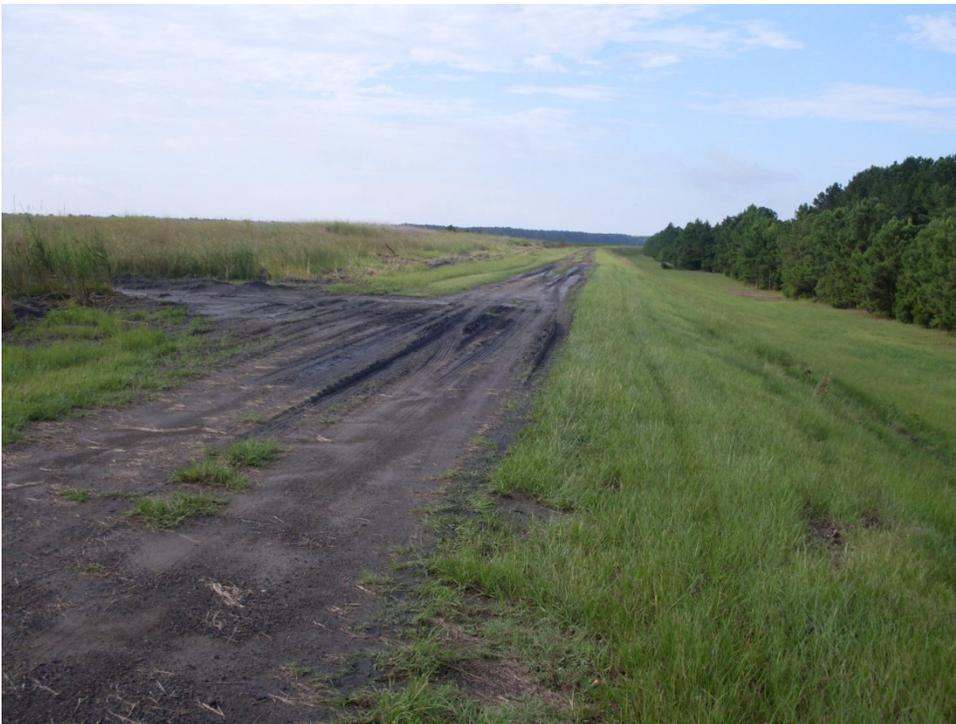
Photo BA-2: Crest of Perimeter Dike at Ash Removal Equipment Access on Ash Pond A – Viewed South.

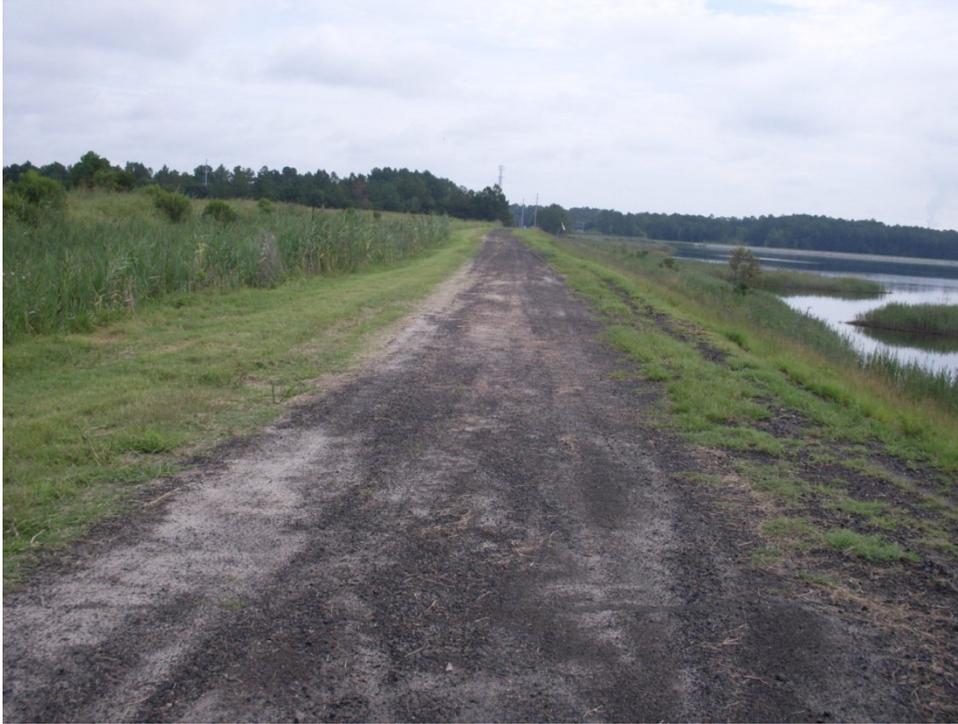
Photo BA-3: Crest of Perimeter Dike East Side of Pond A Near Cross Dike Intersection – Viewed North.

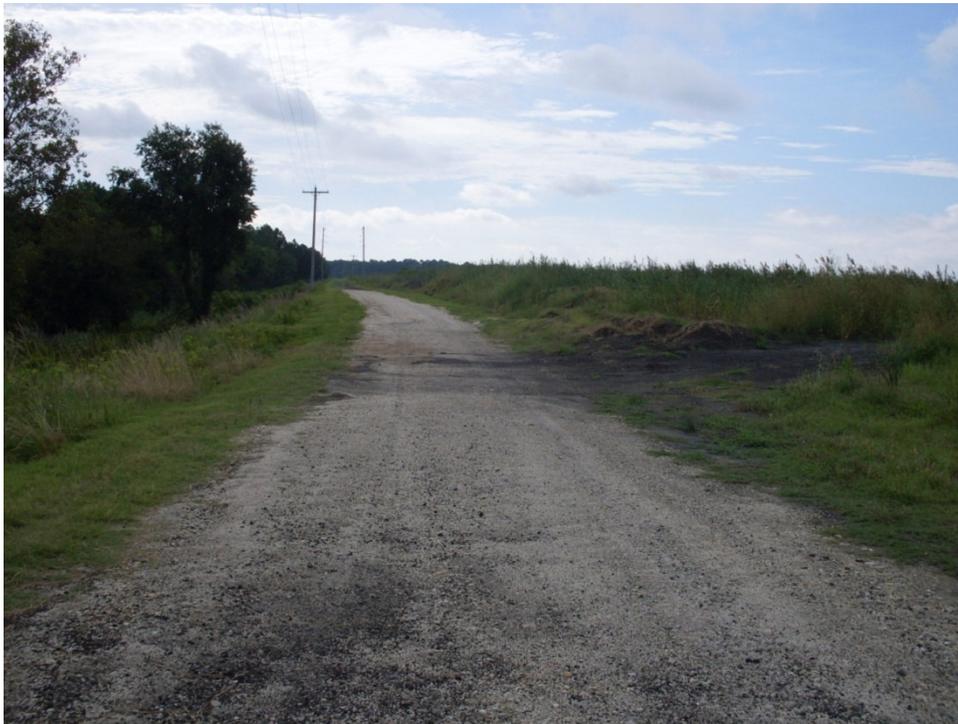
Photo BA-4: Crest of Perimeter Dike North Side of Ash Pond A near Northwest Corner – Viewed East.

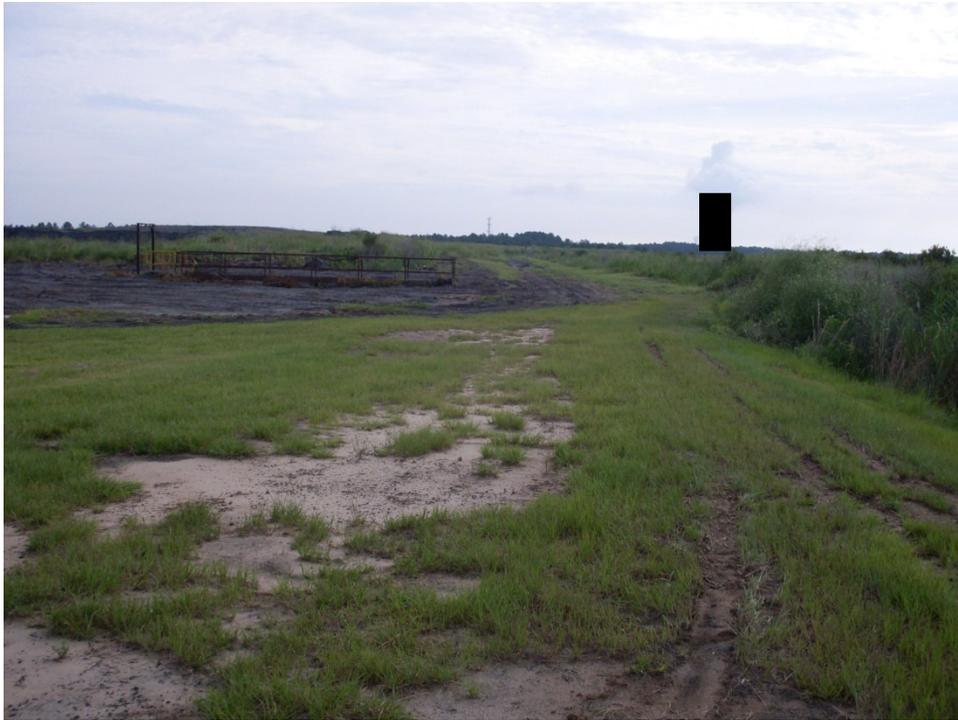
Photo BA-5: Crest of Cross Dike and Walkway to Abandoned Decant Tower and Drainline from Ash Pond A to Ash Pond B – Viewed Northeast.

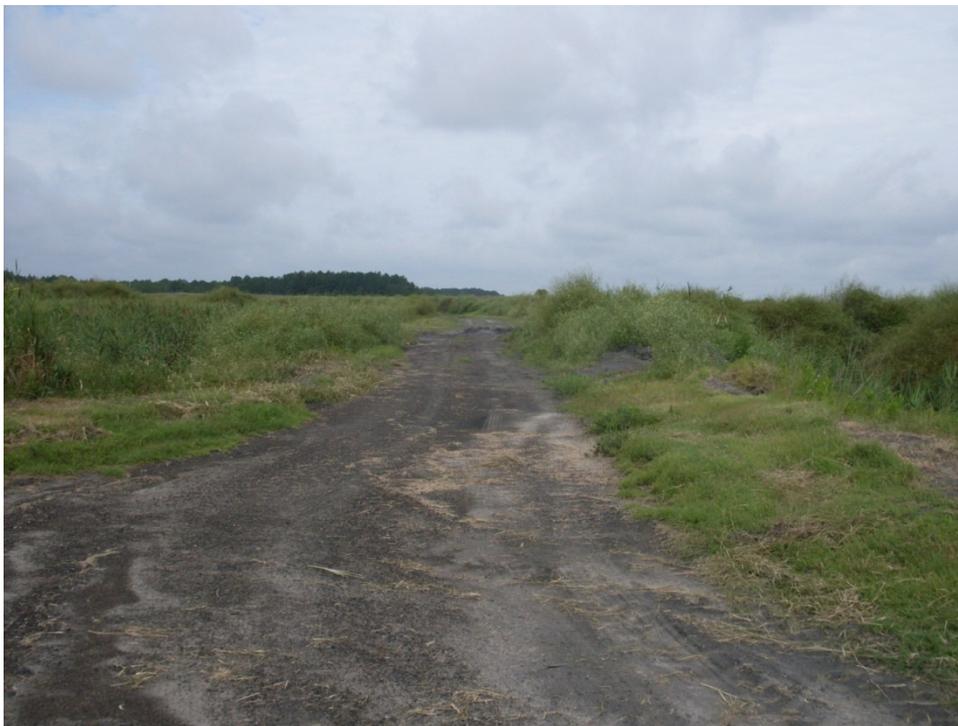
Photo BA-6: Crest of Cross Dike Between Ash Pond B and Ash Pond A – Viewed Southwest.

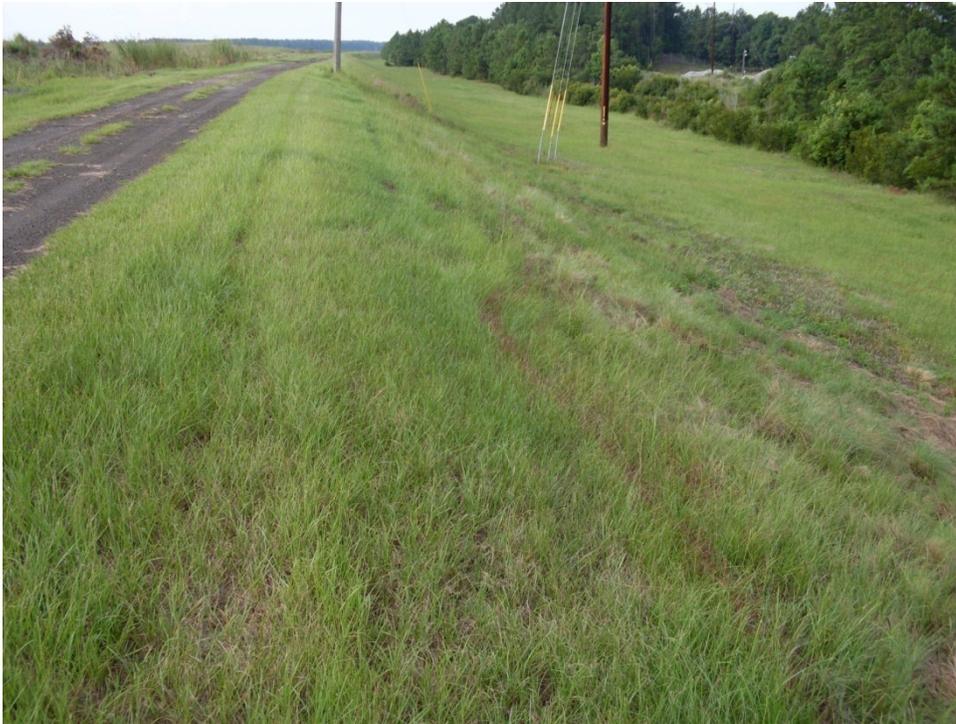
Photo BA-7: Outside Slope of Perimeter Dike at Northwest Corner of Ash Pond A – Viewed South.

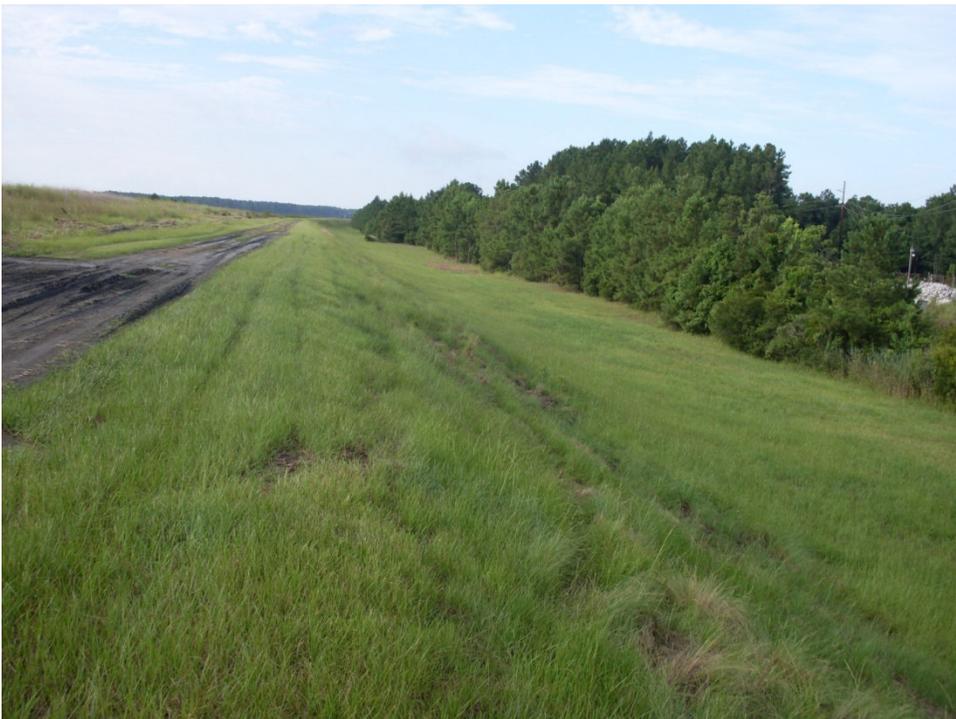
Photo BA-8: Outside Slope of Perimeter Dike West Side of Ash Pond A near a Ash Removal Equipment Access on Ash Pond A – Viewed South.

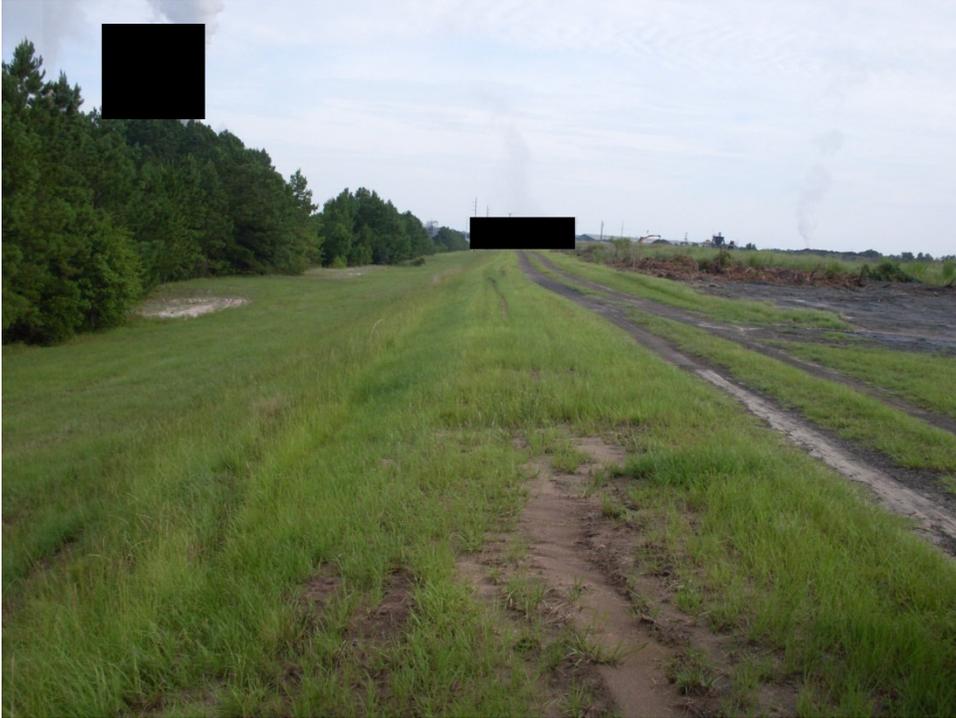
Photo BA-9: Outside Slope of Perimeter Dike at Cross Dike Intersection.

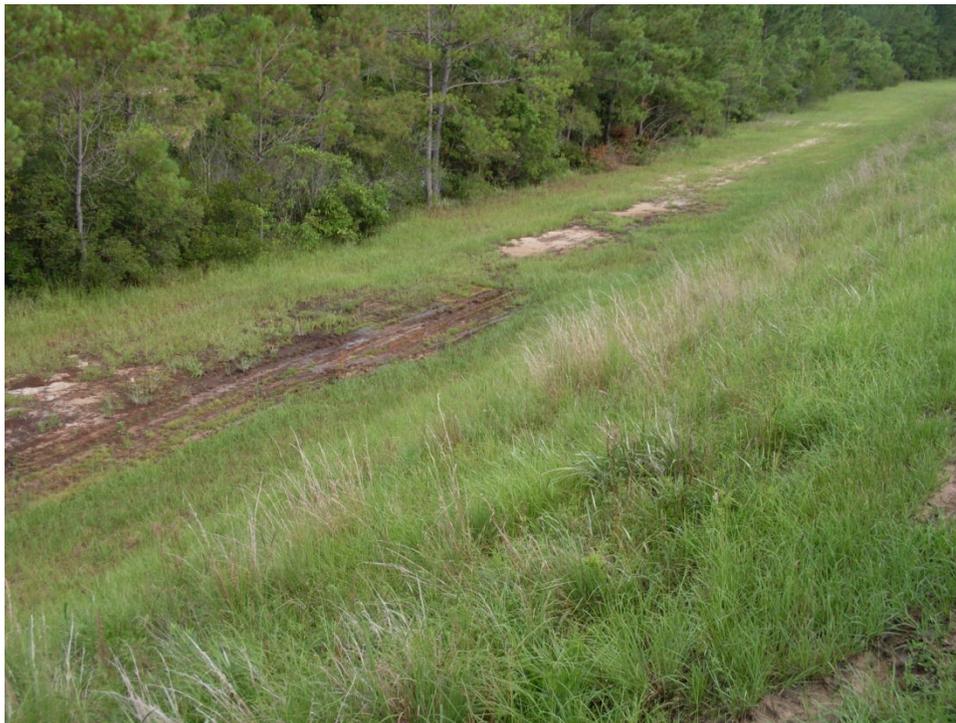
Photo BA-10: Outside Toe of Perimeter Dike at Cross Dike Intersection.

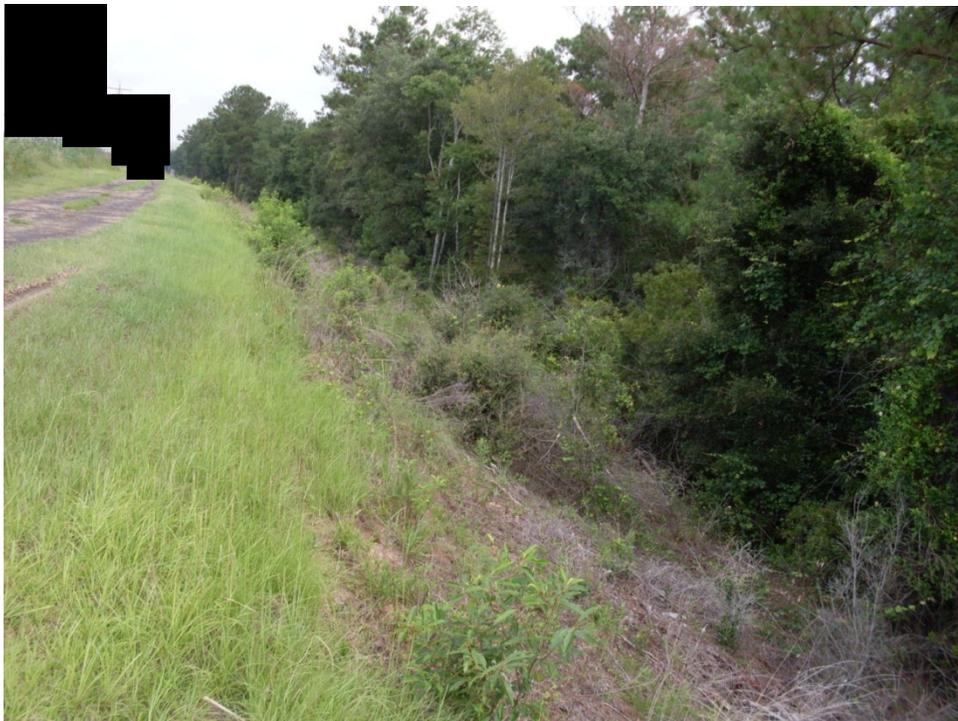
Photo BA-11: Outside Slope of Perimeter Dike North Side of Ash Pond A at Northeast Corner – Viewed West.

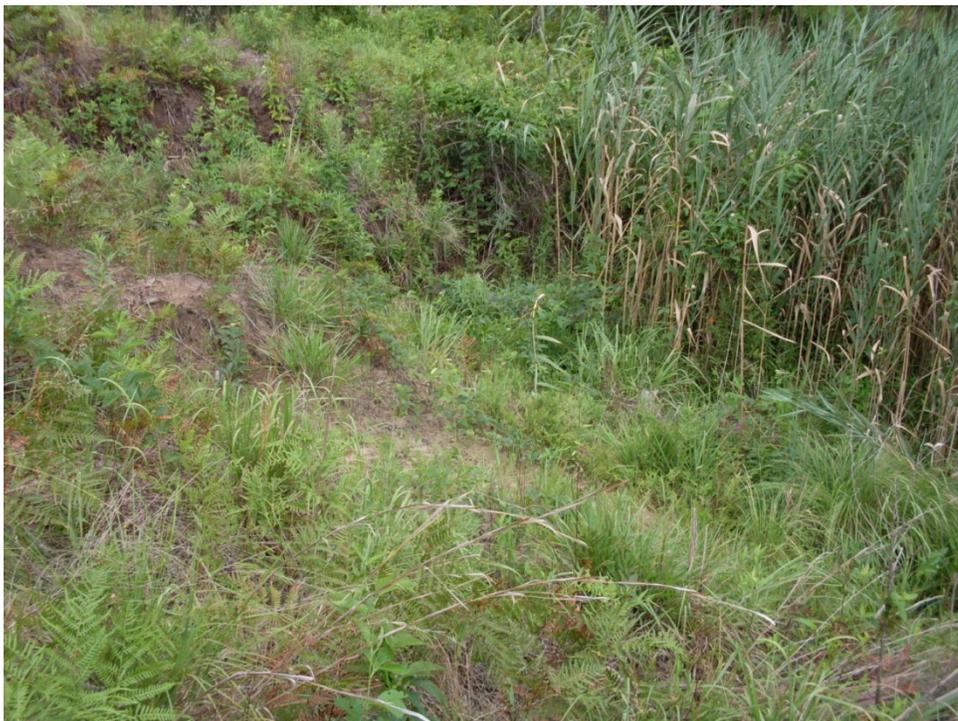
Photo BA-12: Toe of Perimeter Dike North Side of Ash Pond A.

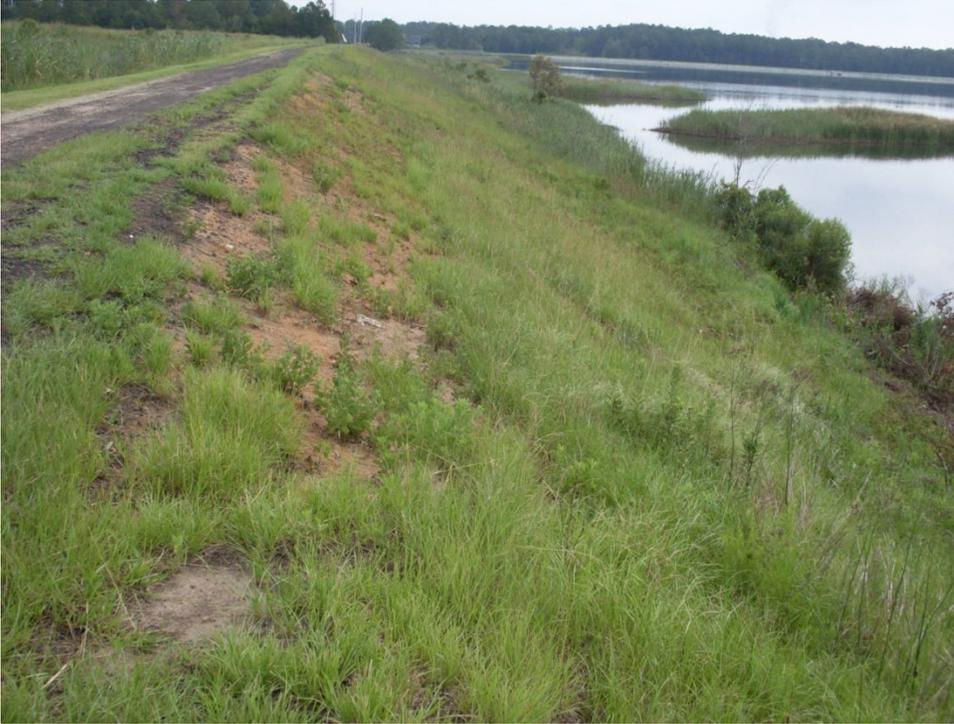
Photo BA-13: Outside Slope of Perimeter Dike East Side of Ash Pond A Near Cross Dike Intersection – Viewed North (Cooling Pond to Right).

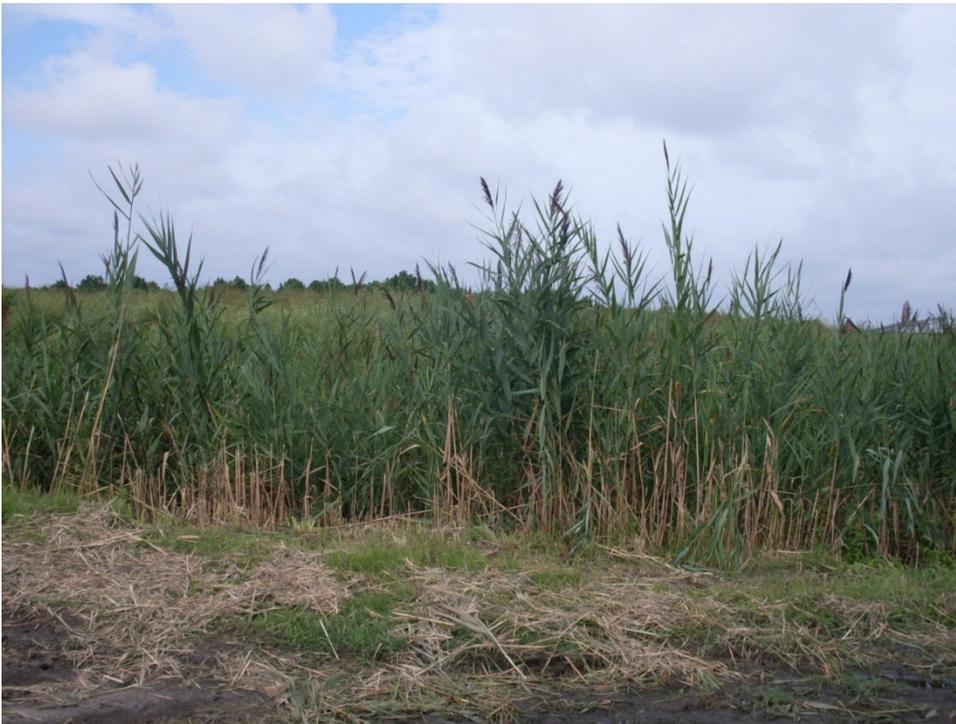
Photo BA-14: Tall Vegetation on Inside of Perimeter Dike North Side of Ash Pond A – Viewed South (Typical View Where Ash Is Not Being Placed or Mined).

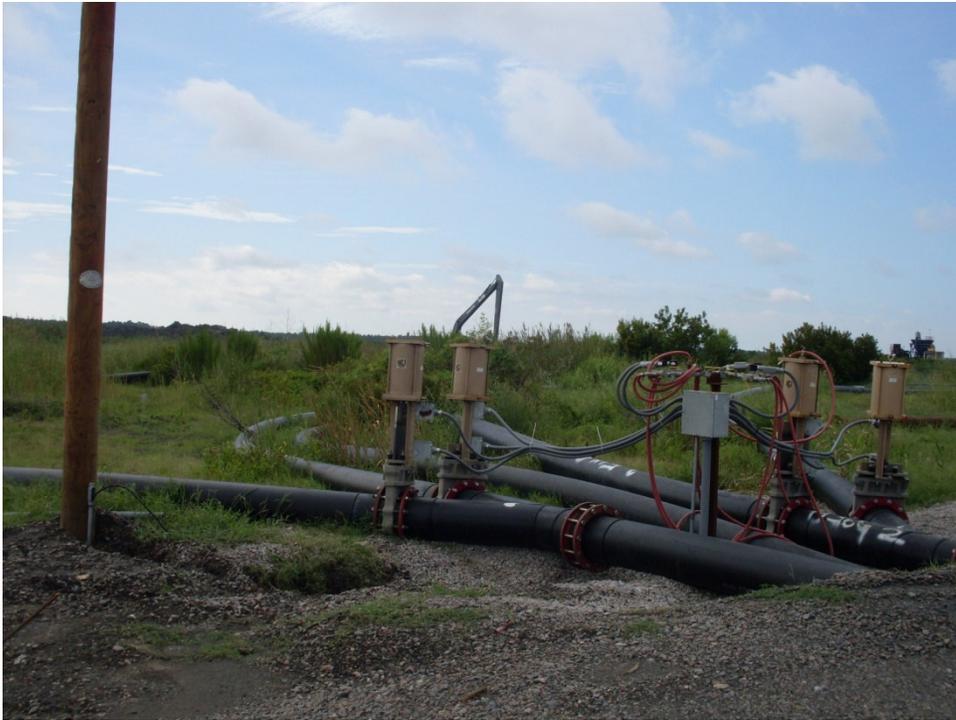
Photo BA-15: Ash Sluice Lines Outside Ash Pond A at Northwest Corner

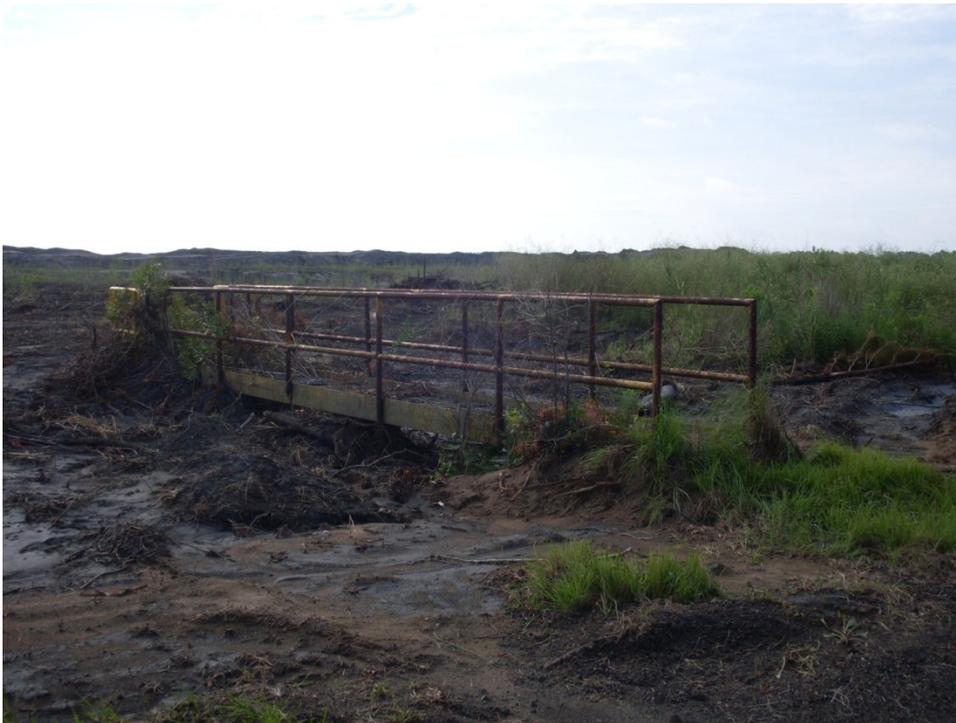
Photo BA-16: Location of Abandoned Decant Tower and CMP Outfall in Ash Pond A that Extends Through West Dike (See Associated Photos BA-13, - 14, and -15).

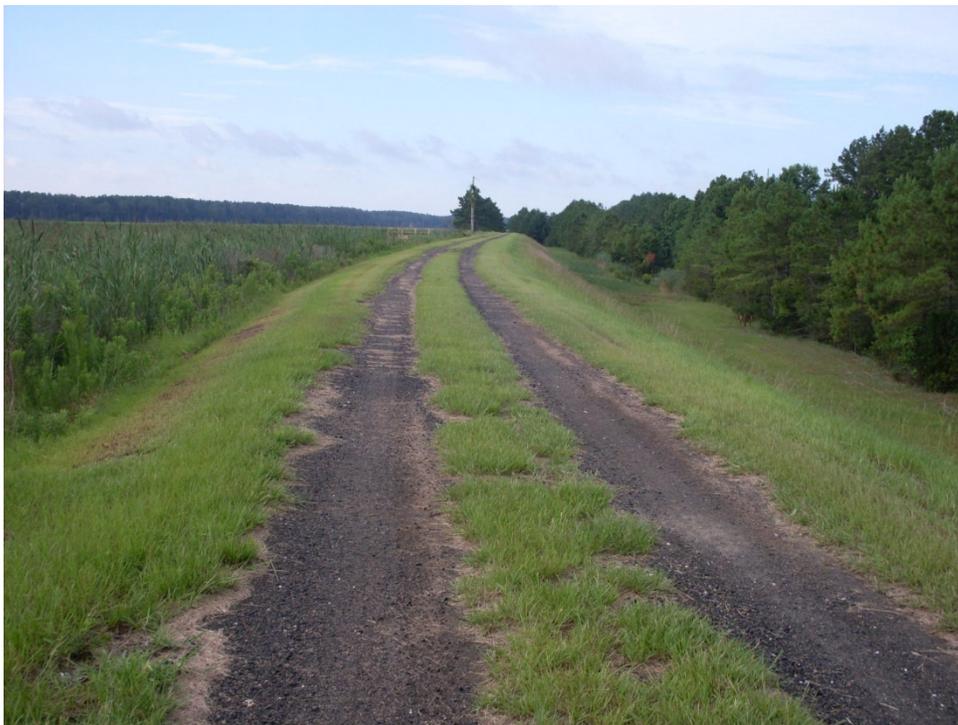
Photo BB-1: Crest of Perimeter Dike at Cross Dike Intersection – Viewed South.

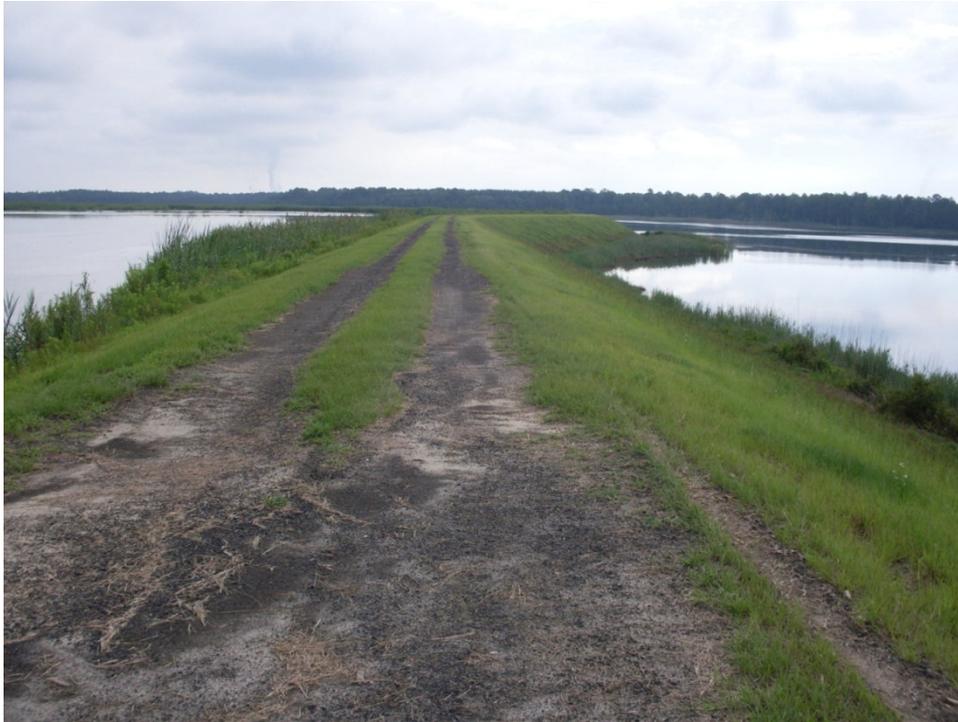
Photo BB-2: Crest of Perimeter Dike South Side of Pond B near South Corner – Viewed Northeast (Cooling Pond to the Right).

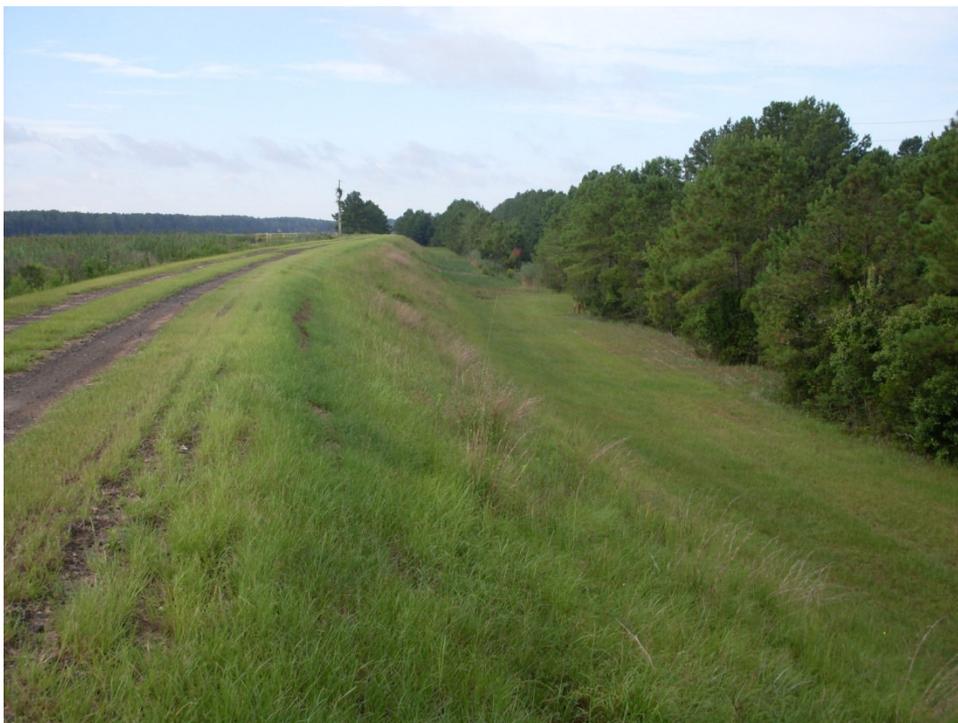
Photo BB-3: Outside Slope of Perimeter Dike West Side of Ash Pond B at Cross Dike Intersection – Viewed South.

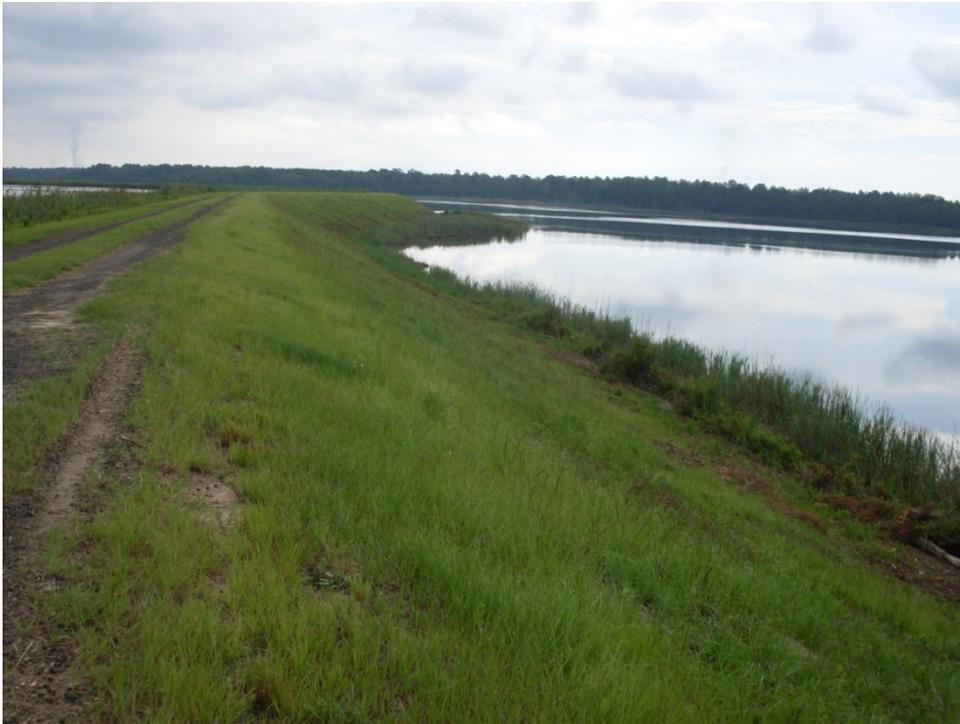
Photo BB-4: Outside Slope of Perimeter Dike South Side of Ash Pond B near South Corner – View Northeast (Cooling Pond to Right).

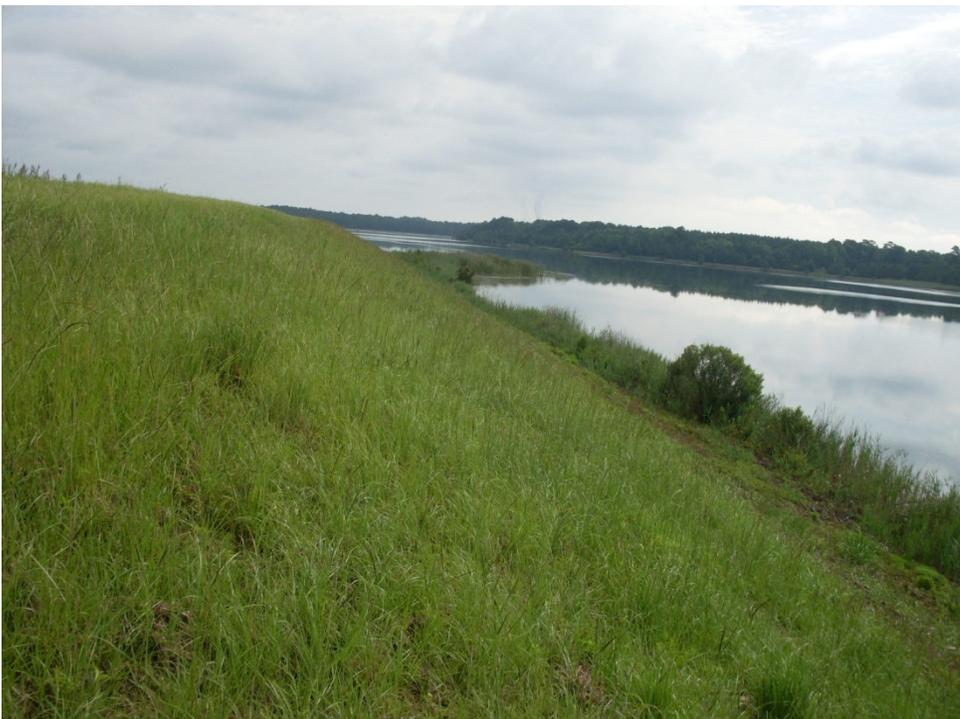
Photo BB-5: Outside Slope of Perimeter Dike near Southeast Corner - Viewed Northeast (Cooling Pond to Right).

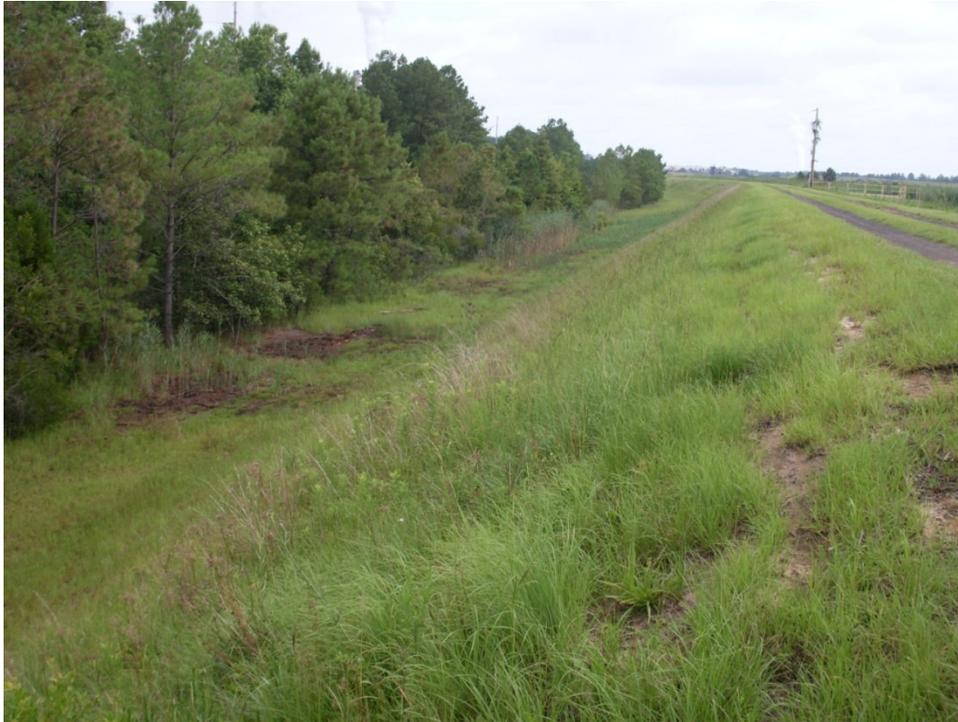
Photo BB-6: Outside Slope and Toe of Perimeter Dike West Side of Ash Pond B near South Corner –Viewed North (Note Wet Area At Toe).

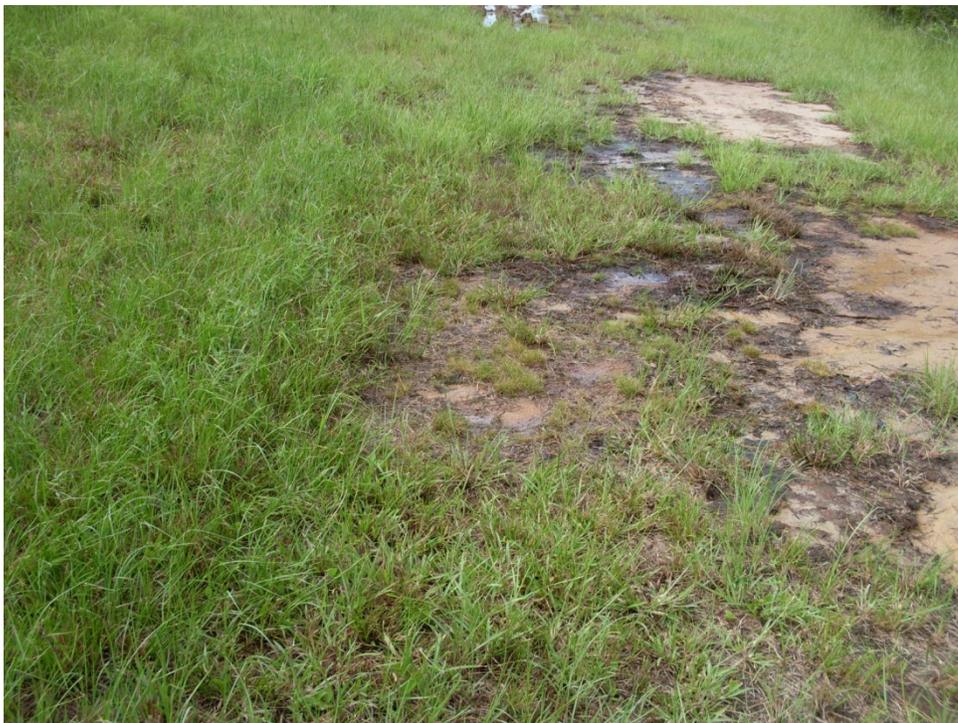
Photo BB-7: Closer View of North Part of Wet Area Shown in Previous Photo.

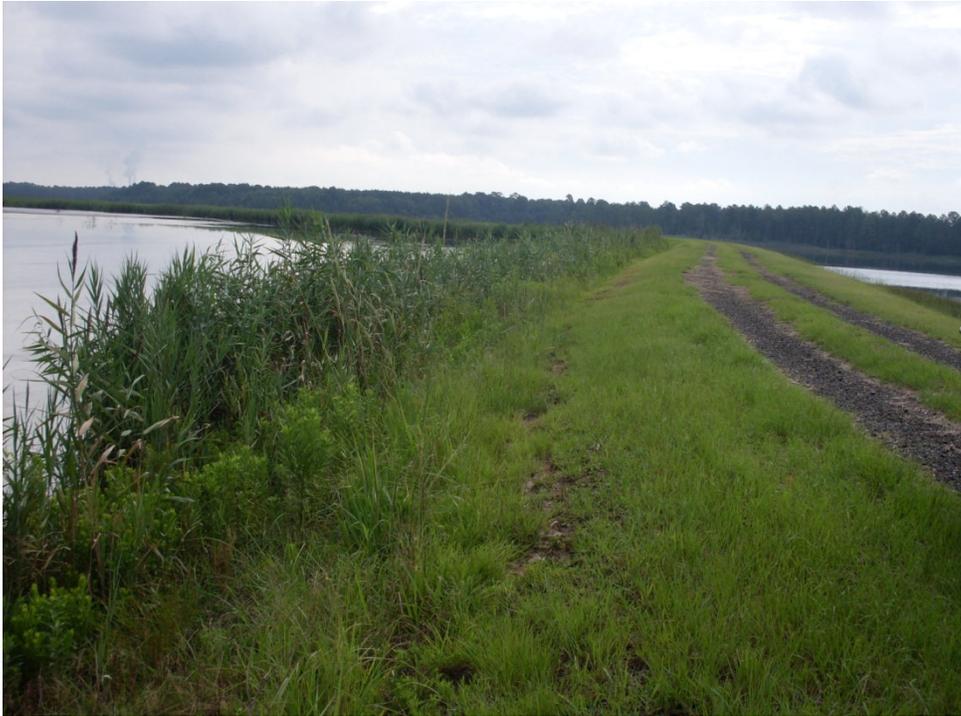
Photo BB-10: Inside Slope of Perimeter Dike East Side of Ash Pond B Near Southeast Bend – Viewed Northeast. (Cooling Pond to Right)

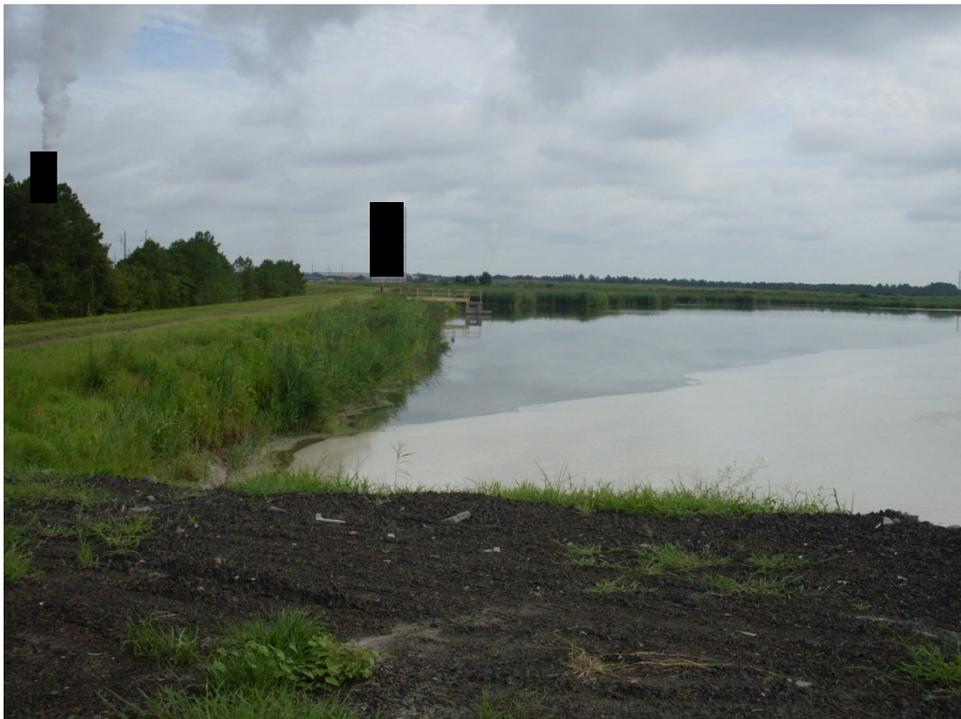
Photo BB-11: Inside Slope of Perimeter Dike West Side of Ash Pond B at South Corner – View North.

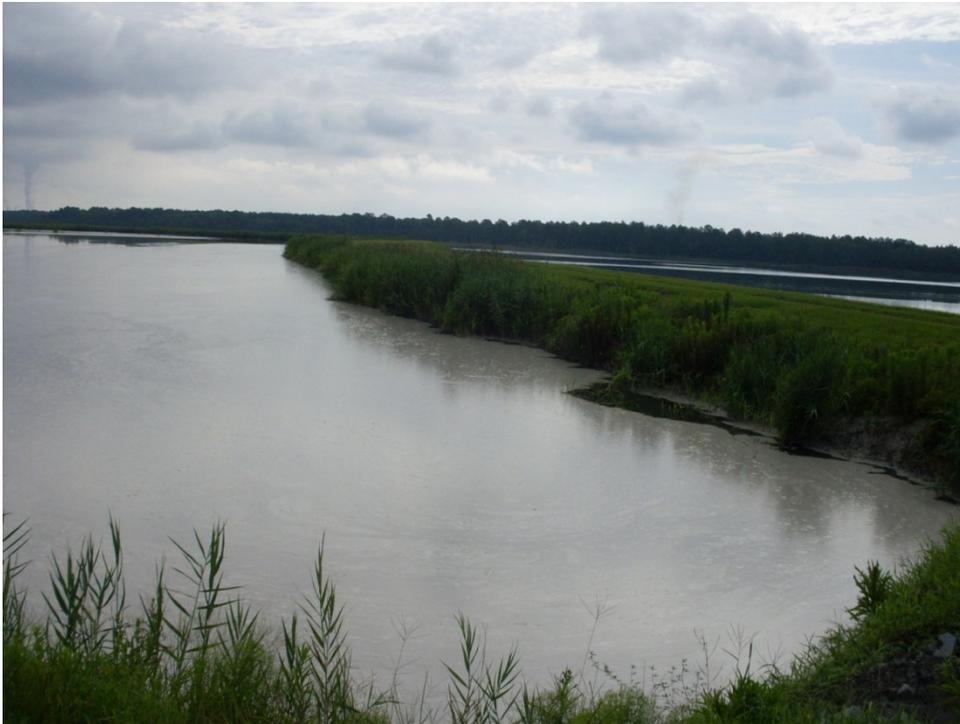
Photo BB-12: Inside Slope of Perimeter Dike South Side of Ash Pond B at South Corner – Viewed Northeast.

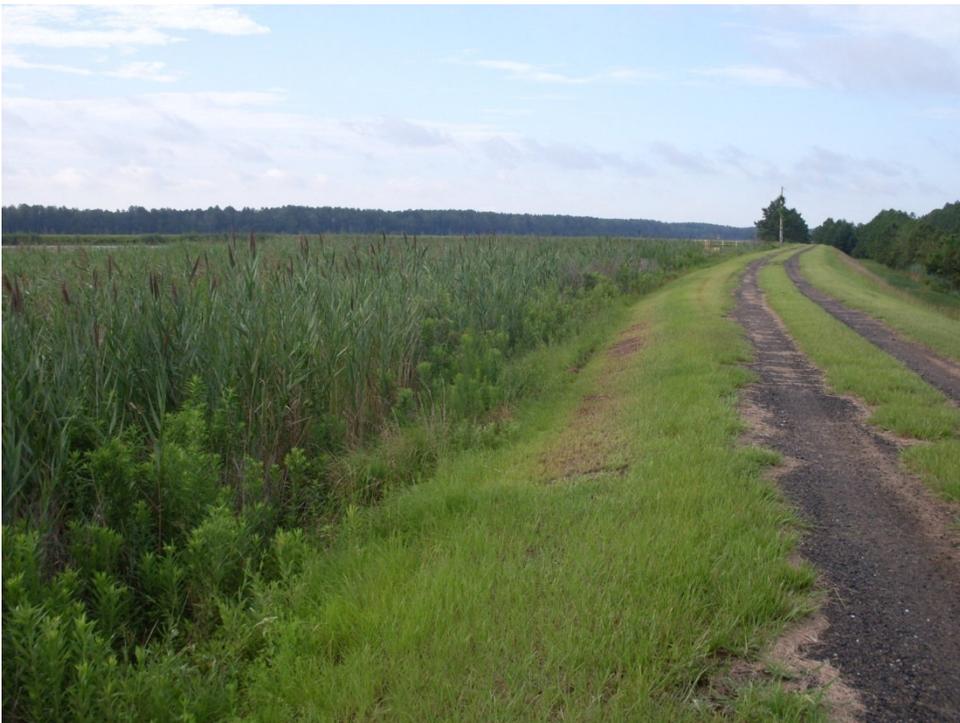
Photo BB-13: Inside Slope of Perimeter Dike West Side of Ash Pond B South of Cross Dike Intersection – Viewed South.

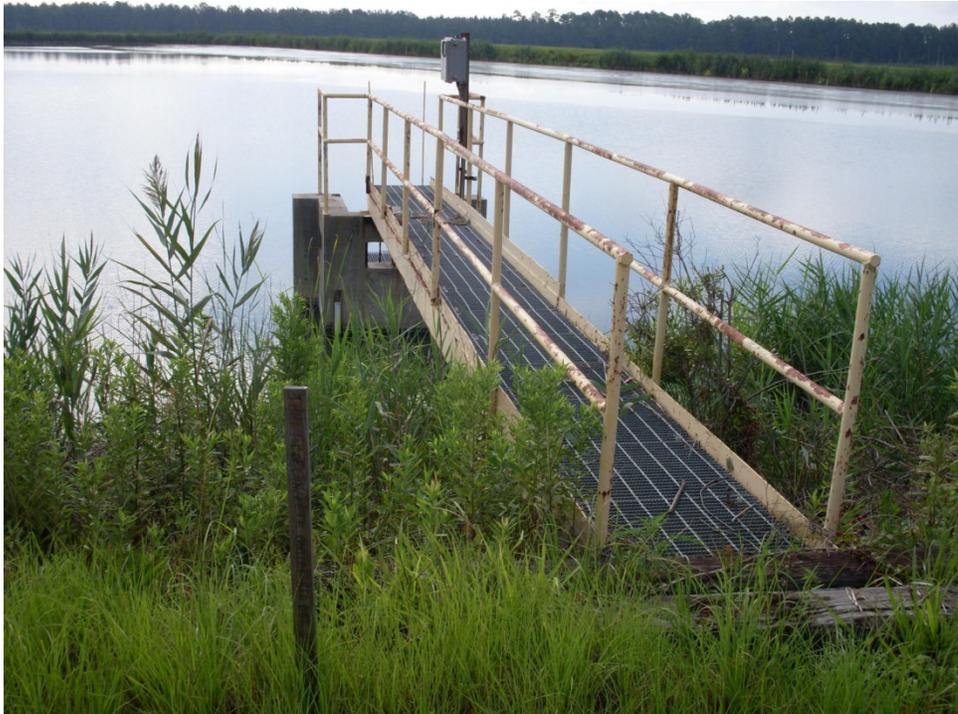
Photo BB-14: View of North and East Side of Ash Pond B Decant Tower.

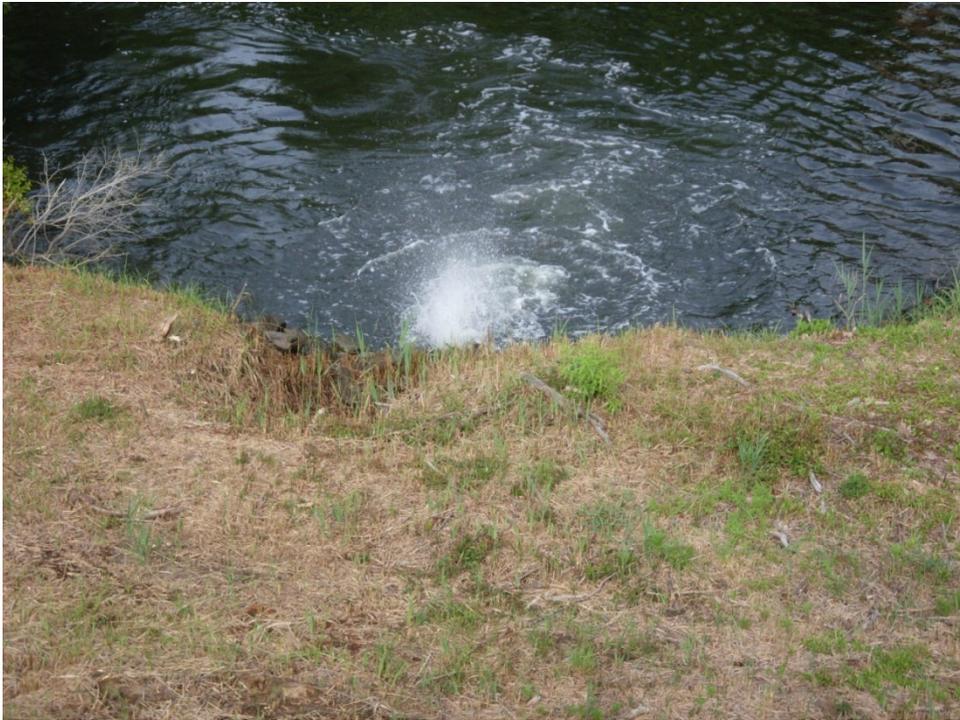
Photo BB-16: View Downstream Along RCP Outfall Pipe of Ash Pond B Decant Tower. (Note “blow” of discharge from partially submerged outlet due to entrapped air.).

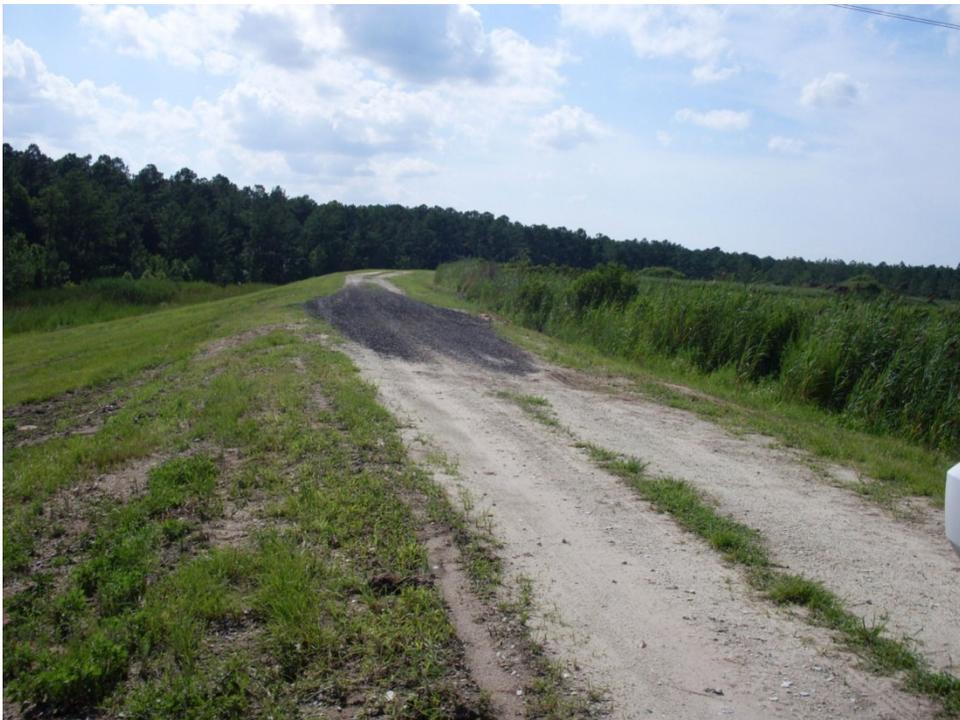
Photo BS-1: Crest and Outside Slope of Perimeter Dike at Southwest Bend of South Ash Pond – Viewed West.

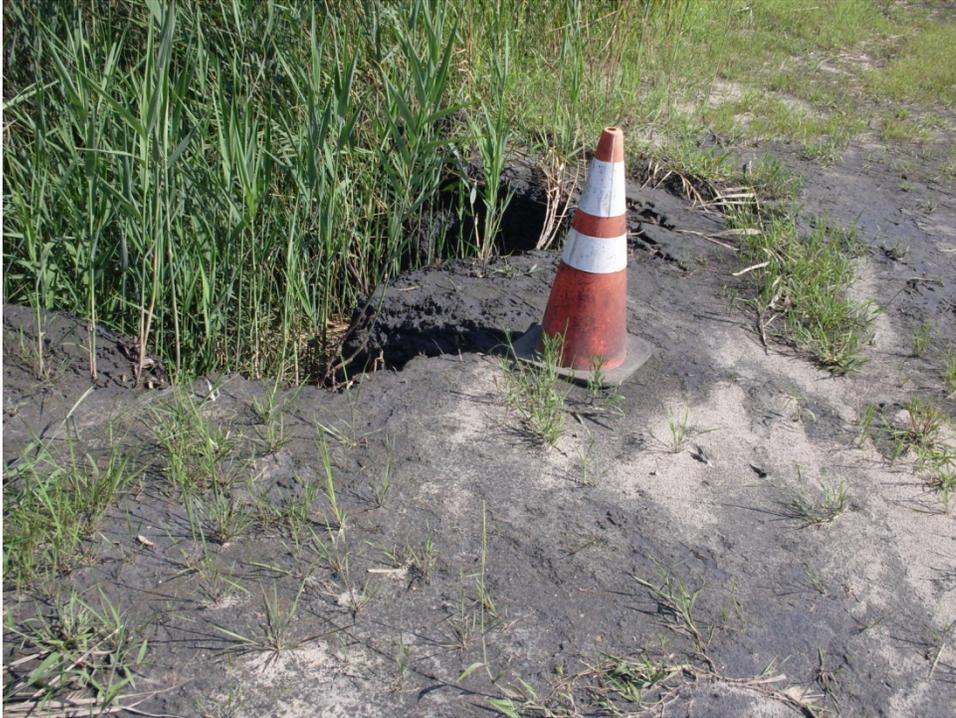
Photo BS-2: Ash Washout Adjacent to Crest of Perimeter Dike of South Ash Pond at Western End.

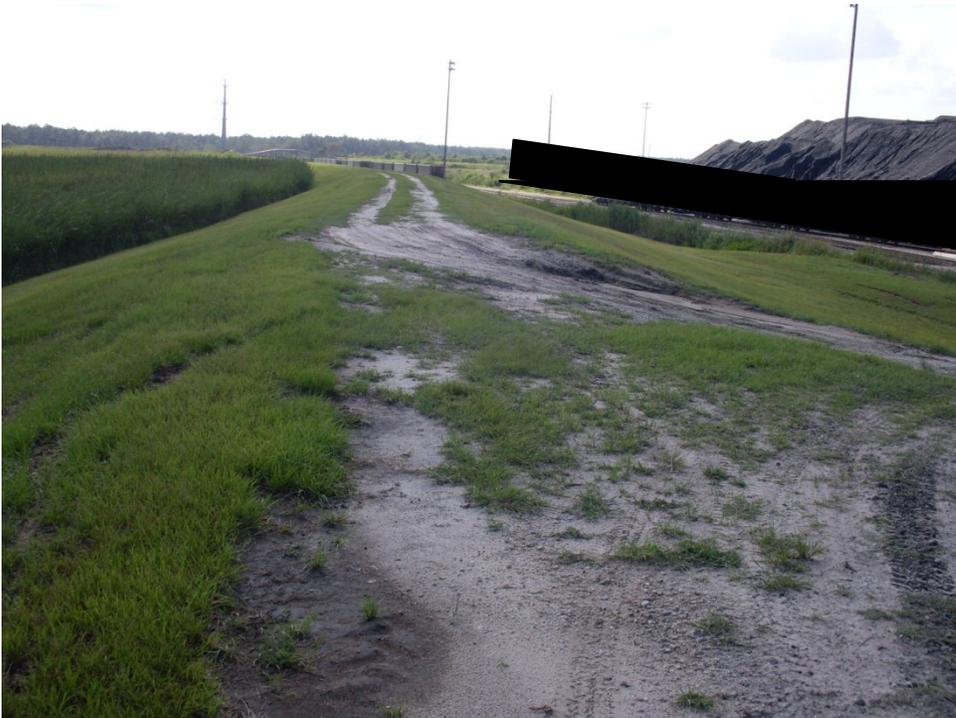
Photo BS-3: Crest of Perimeter Dike North Side of South Ash Pond Perimeter Dike at Access Road – Viewed West.
